DESTROYER REPORT

GUNFIRE, BOMB AND KAMIKAZE DAMAGE

25 January, 1947

WAR DAMAGE REPORT No. 51

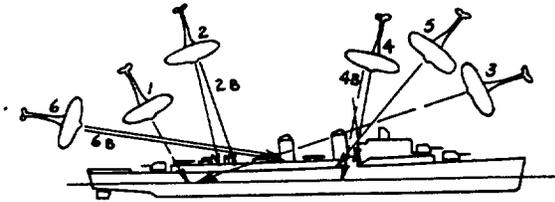
- 1 Near miss crash. Engine and propeller hit Mt. 3.
- 2 ZEKE hit Mt. 44.
- 2B Bomb blew out side after engineroom.
- 3 Near miss crash damaged rigging and No.1 stack.
- 4 VAL hit main deck, frame 81.
- 4B Near miss bomb blew side forward fireroom.
- 5 VAL crashed deckhouse frame 90.
- 6 Plane hit after stack.
- 6B Bomb detonated in aft uptakes.

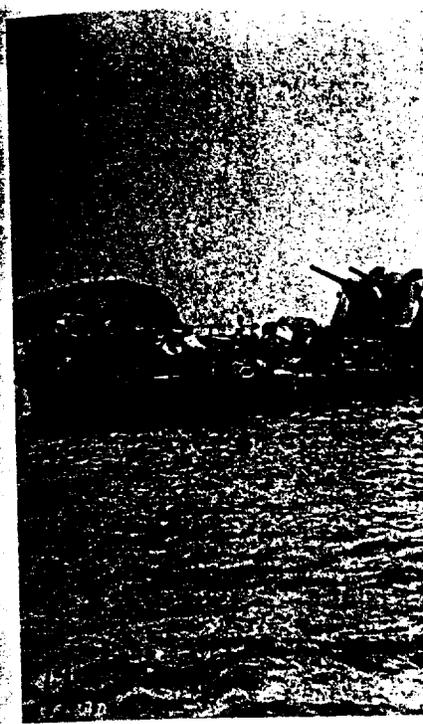
Photo 2-1: AARON WARD

Photos 2-1 and 2-2: The two photographs on the page opposite are classic illustrations of the survival power of the modern U. S. destroyer. The AARON WARD shown was one of the minelayers converted from 692 Class destroyers and should not be confused with DD483 which was sunk in 1943. She was hit as shown in the above diagram by six Kamikazes and three large bombs, estimated to have been 250 Kg GP. All spaces between bulkheads 72 and 170 flooded to the waterline except for the forward engineroom and certain starboard water tanks. Free surface extended through five major compartments. 1650 tons of water were shipped and GM was reduced to approximately 1 foot positive. Severe gasoline and ammunition fires were brought under control after about two hours with the assistance of LCS83 alongside. Firemain pressure and power forward remained available throughout due to use of the forward emergency Diesel generator. AARON WARD arrived at Kerama Retto with no freeboard aft, 18 feet draft forward and a 5-degree starboard list. After emergency repairs she proceeded under her own power to Navy Yard, Pearl Harbor, using the starboard shaft.
